PUTTING RESEARCH TO WORK

BRIEF

Protective Coatings Prevent Bridge Beam End Corrosion

This brief summarizes Project 0092-01-06, "Rehabilitation Techniques for Concrete Bridges," produced through the Wisconsin Highway Research Program for the Wisconsin Department of Transportation Research, Development & Technology Transfer Program, 4802 Sheboygan Ave., Madison, WI 53707.

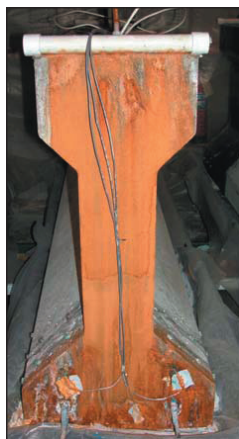
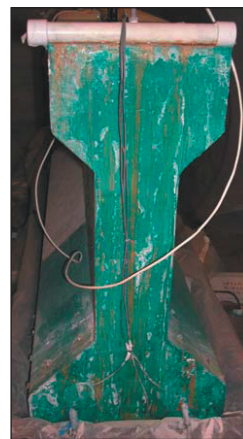
After six months of laboratory exposure to salt spray cycling, an uncoated concrete beam (left) suffered significant end corrosion. An adjacent beam, this one coated with a polymer resin, showed little damage.

Researchers found the most effective method of preventing beam end corrosion was to apply a polymer resin coating to beam ends before installing them in the field. The FRP wrap was about equally effective, but more costly and difficult to install than the polymer resin coating. Epoxy coating was the next best solution, followed by the solvent-based sealer.
